UNDERWATER BRIDGE INSPECTION REPORT

STRUCTURE NO. 4886

CR NO. 19

CLEARWATER RIVER

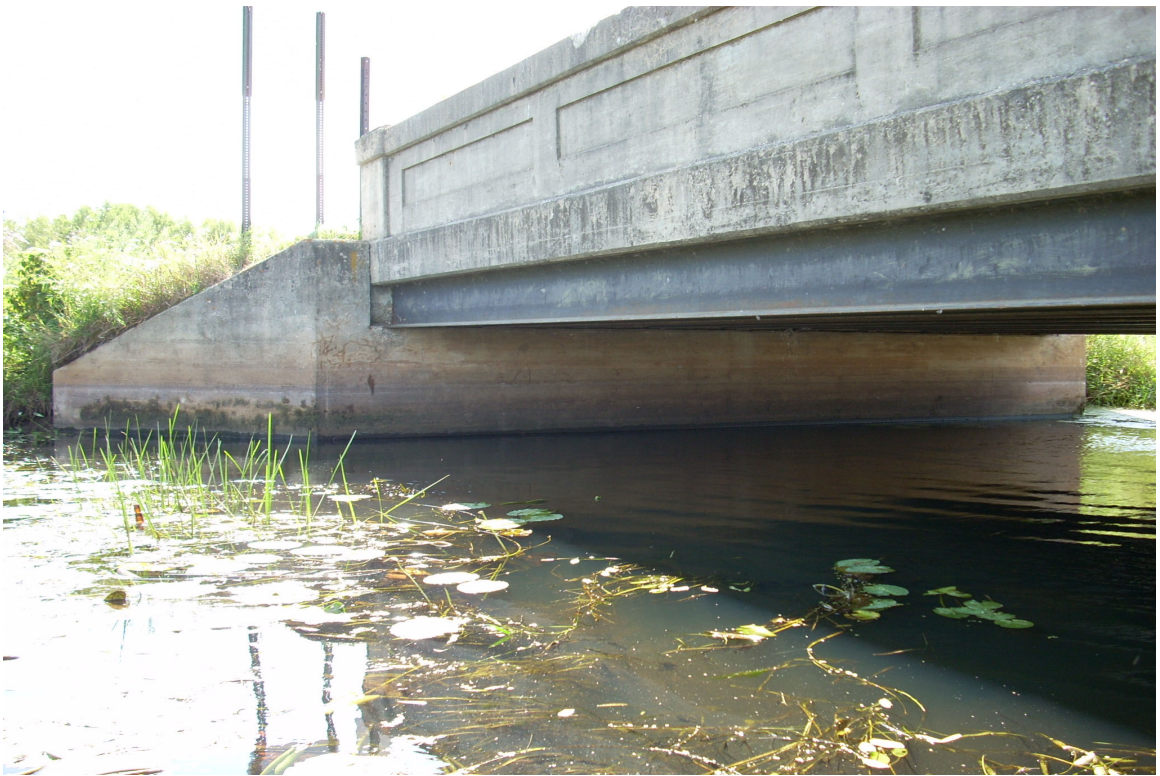
Photograph 2. View of East Abutment, Looking Southeast.

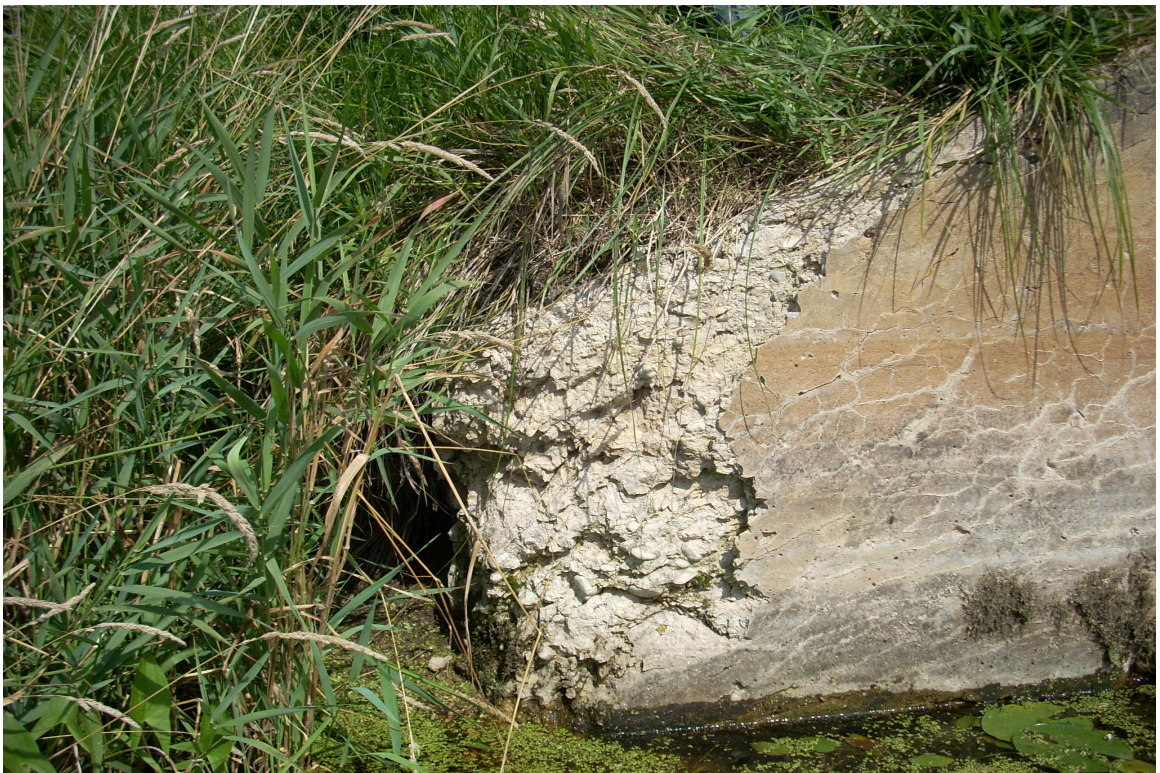
Photograph 4. View of Deteriorate Concrete at South end of Southwest Wingwall.

- 7 The end of Southwest wingwall was delaminated. The area measured 1 foot wide, 3 feet high, with 6 inches of penetration, with no exposed rebar.

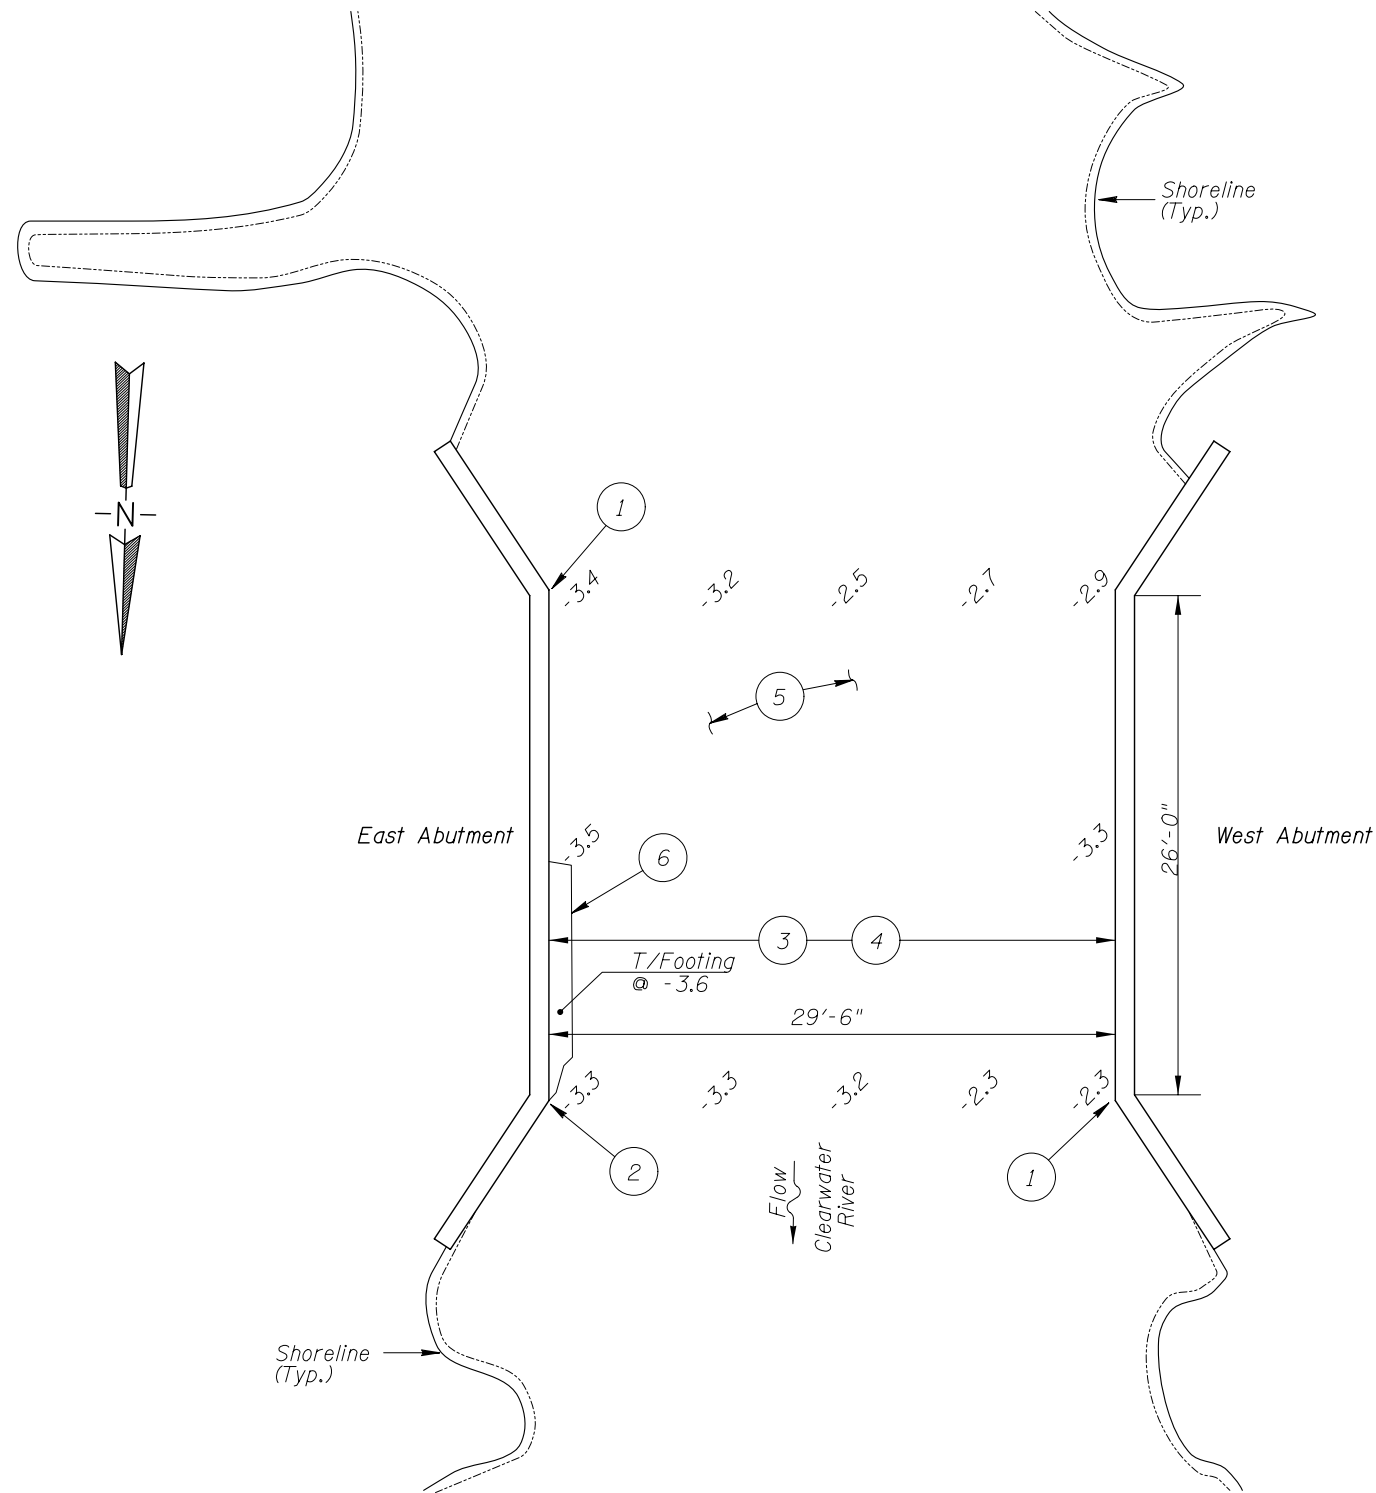
INSPECTION AND SOUNDING PLAN

- 1 Loss of section at the joint between the southeast wingwall and East Abutment. It is 4.8 feet below the top of the wing wall measuring 1 foot in diameter with a maximum penetration of 1.5 inches with no exposed rebar.

- 2 Spall was observed at East Abutment below northernmost beam seat measuring 8 inches in diameter, with a maximum penetration of 1 inch with no exposed rebar.

- 3 Random vertical cracks extending from the bridge seat down 4 feet measuring from hairline to 1/16 inches wide located approximately every 5 feet along both abutment faces.

- 4 Above and below the waterline the concrete was typically smooth and sound with areas of hairline map cracking on the wingwalls and on the abutment faces for the first 3 feet from the wingwalls.

- 5 The channel bottom consisted of silty sand with 1 foot of probe rod penetration.
- 6 Footing exposure was observed along the East Abutment from north end to midpoint with no vertical exposure.
